Ice Jam Develops on the Grand River at North Park Street Bridge

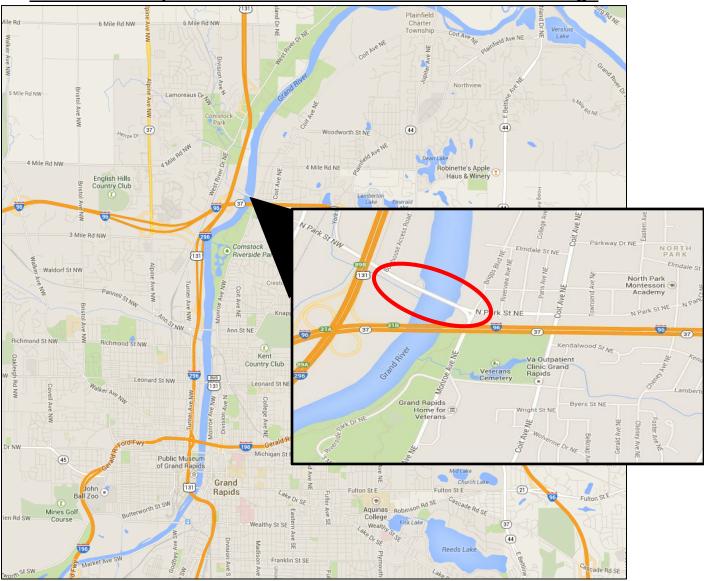
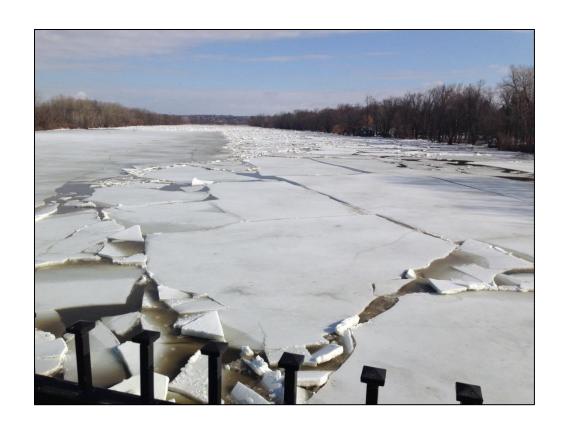
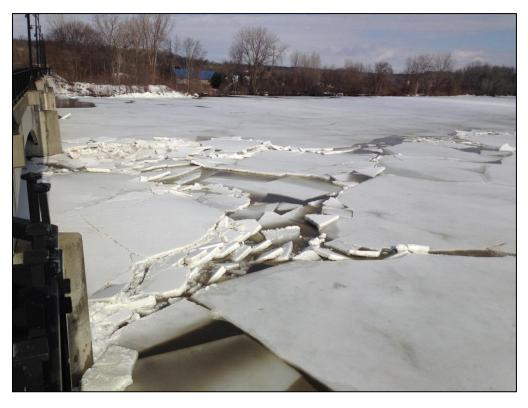
Large sheets of ice (estimated to be around 8 inches thick) were observed on the Grand River this morning around Comstock Park. These sheets and chunks of ice made it downstream and jammed against the North Park Street Bridge. River levels at Comstock Park were observed at 11.70 feet at 7:40 a.m. By 9:07 a.m., levels steeply increased to 12.50 feet. Levels have since partially stabilized at 12.40 feet. Ice jams can cause rapid fluctuations on area rivers with little or no warning. The situation will continue to be closely monitored. Any further information and updates will be disseminated as they come available. It is advised that residents along the Grand River keep a close eye on water levels, as well as keep abreast of the latest updates from the National Weather Service. For updated forecasts, please visit http://www.crh.noaa.gov/grr/
